RE: AZS Chemical Company (a.k.a. Cargill)
Atlanta, Fulton County, Georgia
Preliminary Assessment Report

**PRELIMINARY ASSESSMENT
AZS CHEMICAL CO. (a.k.a. CARGILL)
762 MARIETTA BLVD. N.W.
ATLANTA, FULTON COUNTY, GEORGIA
EPA ID #s GAD981237225 & GAD057288144**

Photo	1 of 45	Date:	09/24/2007	Site Name:	AZS Corporation		
Photographer:	Thomas J Brodell, QEP; HWMB			City:	Atlanta	County:	Fulton
Explanation:	MW-1, the designated background well. Currently used as a bathroom facility by indigents living on property as indicated by partially decomposed toilet paper around well. Well found unlocked.

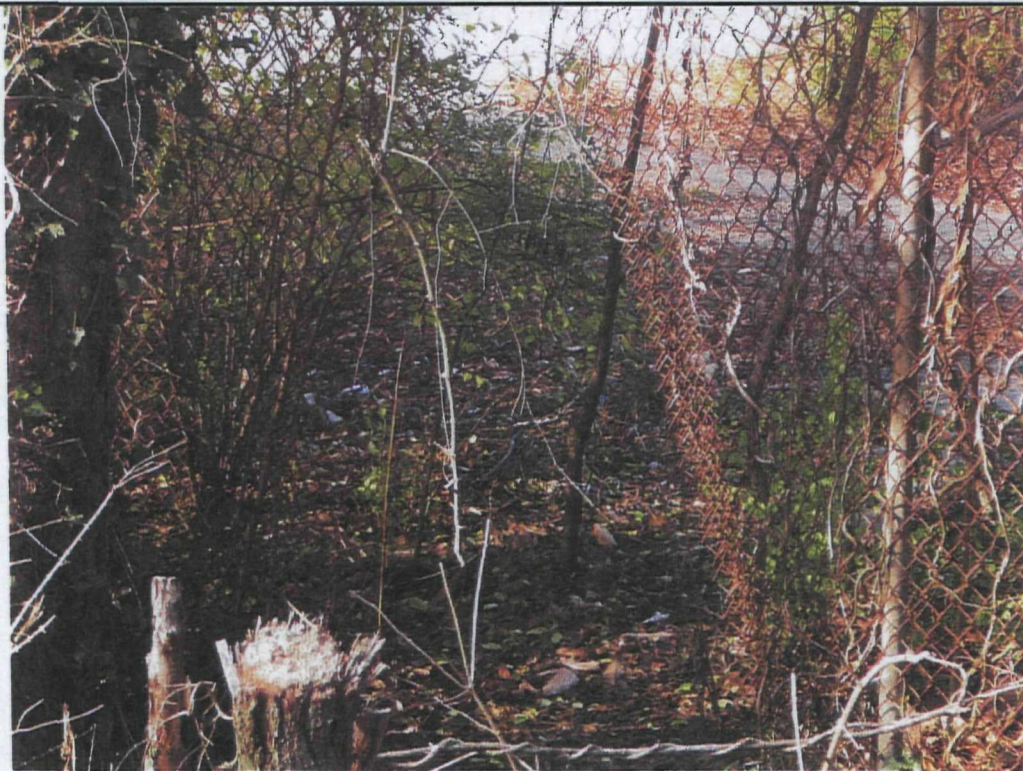
Photo	04 of 43	Date:	11/29/07	Site Name:	AZS Corporation		
Photographer:	Thomas J Brodell, QEP; HWMB			City:	Atlanta	County:	Fulton
Explanation:	Closeup of hole in fence shown in Photo # 03.

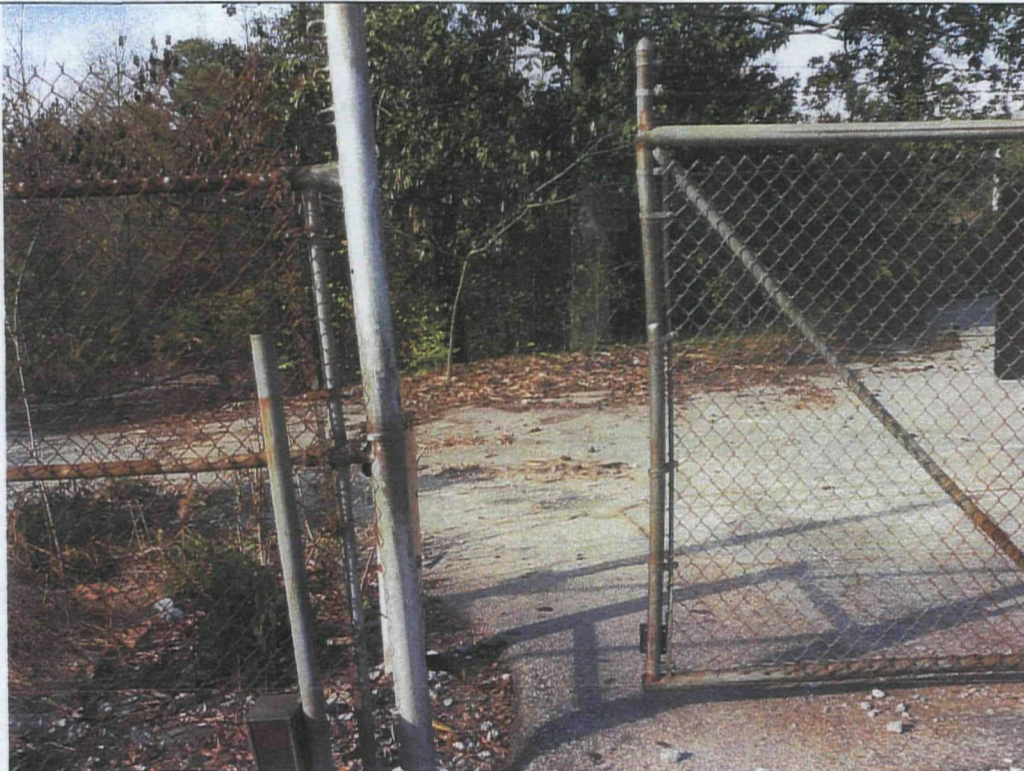
Photo	05 of 43	Date:	11/29/07	Site Name:	AZS Corporation		
Photographer:	Thomas J Brodell, QEP; HWMB			City:	Atlanta	County:	Fulton
Explanation:	Gate between Photo #s 01 and 02. Gate partially open and unlocked. No signs prohibiting entry or trespass observed present.

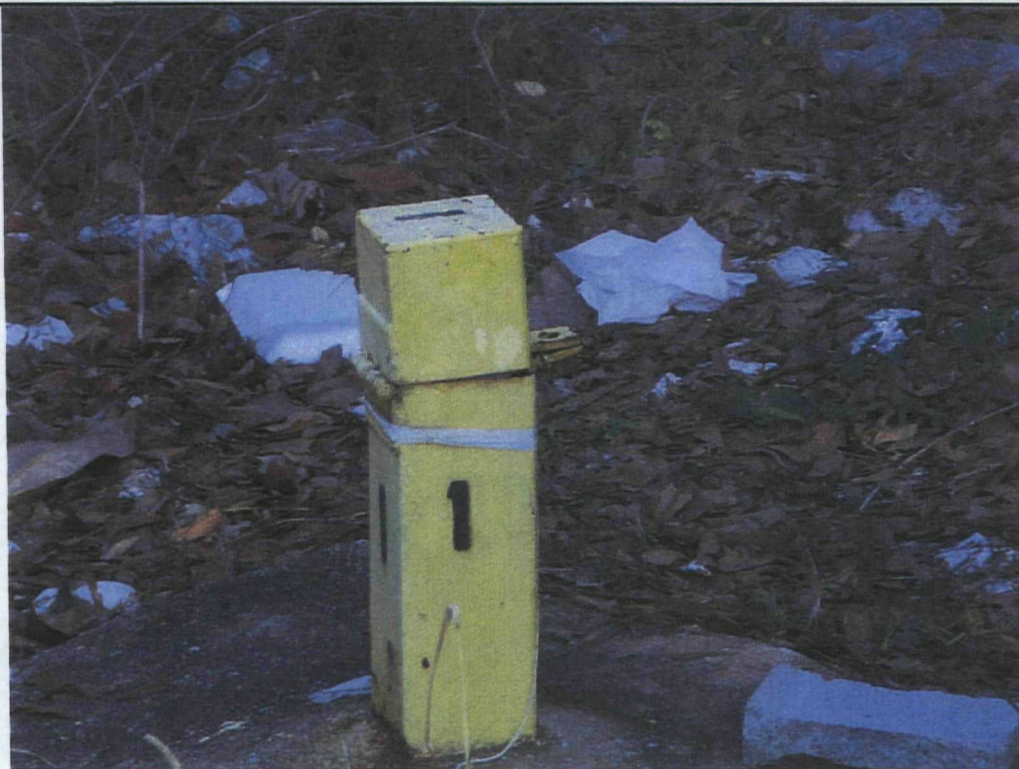
Photo	06 of 43	Date:	11/29/07	Site Name:	AZS Corporation		
Photographer:	Thomas J Brodell, QEP; HWMB			City:	Atlanta	County:	Fulton
Explanation:	Background monitoring well (MW-1). No lock present and area shows evidence of being used as a privy.

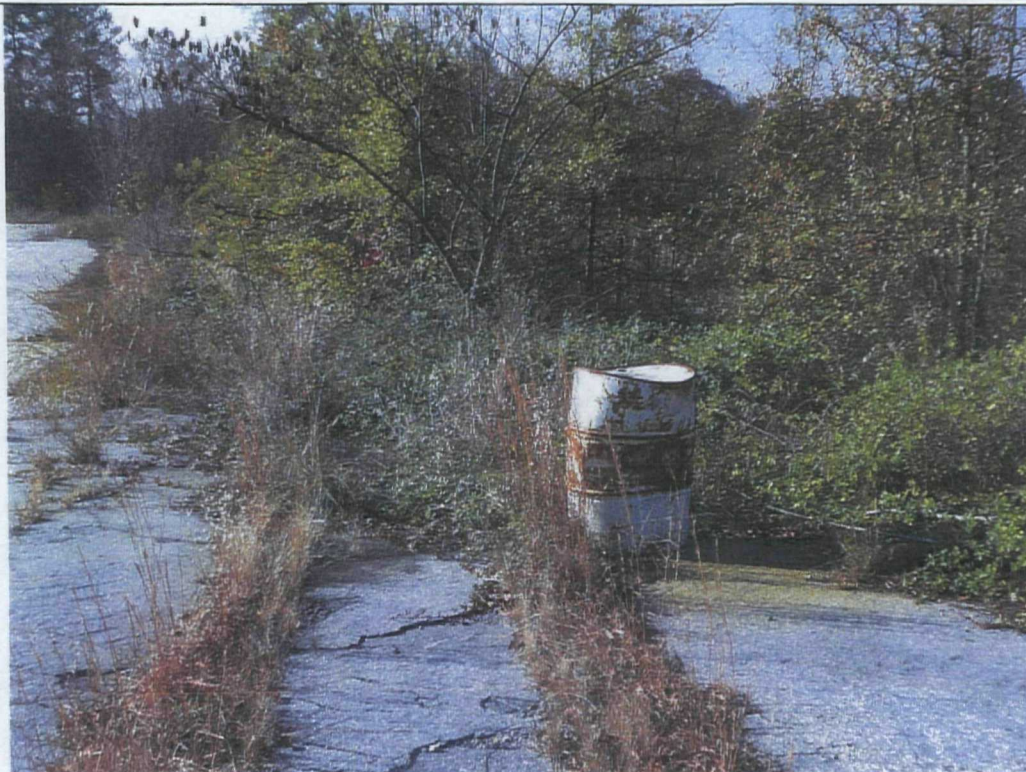
Photo	07 of 43	Date:	11/29/07	Site Name:	AZS Corporation		
Photographer:	Thomas J Brodell, QEP; HWMB			City:	Atlanta	County:	Fulton
Explanation:	Empty 55-gallon Drum near former Railroad Siding between former Truck Lot, former Warehouse and former Tank Car Unloading Transfer Center

The drums observed on-site during the 2007 CEI (see Photo #s 07, 08, 11, 22, 23, 25 and 26) remain on-site. One drum (see Photo # 22) continues to exhibit clear evidence of corrosion and salt formation on the outside of the drum. Three additional drums, apparently filled with solids, were observed during the reconnaissance (see Photo #s 21, 24 and 42), possibly due to the dying off of overgrowth with the colder weather. This raised the total number of drums to ten, eight of which are apparently filled with solids. Except for one drum (see Photo # 11) observed during the 2007 CEI, no labeling was observed, and labeling on this drum remains illegible. All drums were observed on areas of the facility owned by United Real Property.

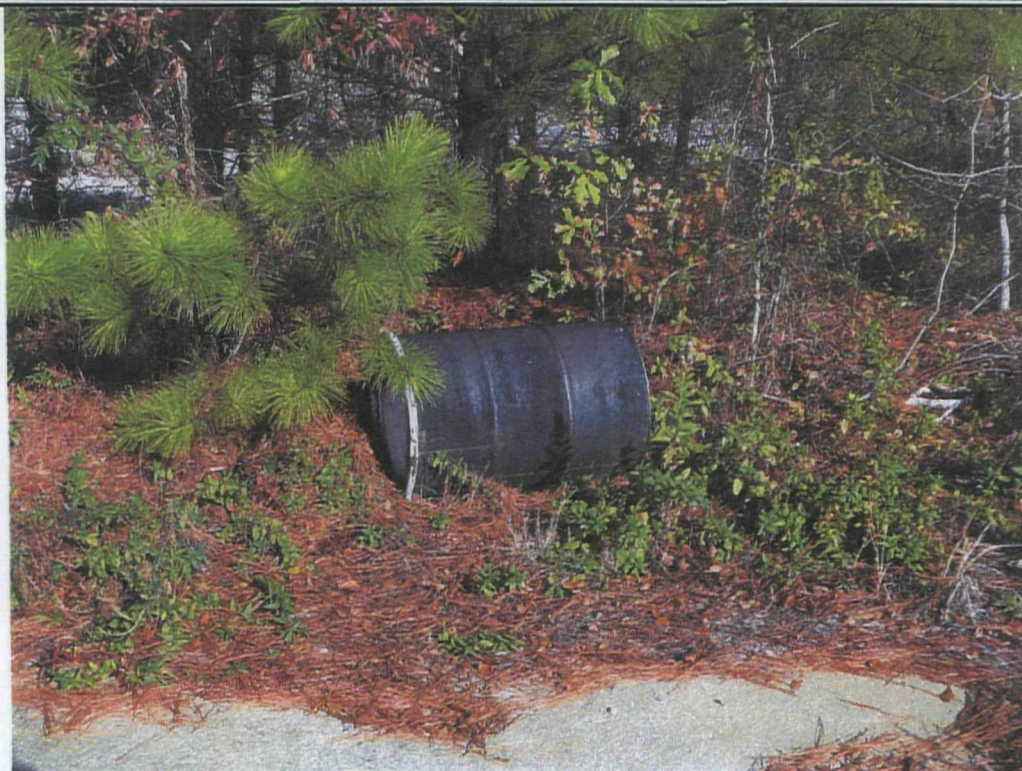
Photo	08 of 43	Date:	11/29/07	Site Name:	AZS Corporation		
Photographer:	Thomas J Brodell, QEP; HWMB			City:	Atlanta	County:	Fulton
Explanation:	55-gallon drum filled with solids approximately 10 yards north of the drum shown in Photo # 07. Drum located just off of road surface where it changes from asphalt to concrete.

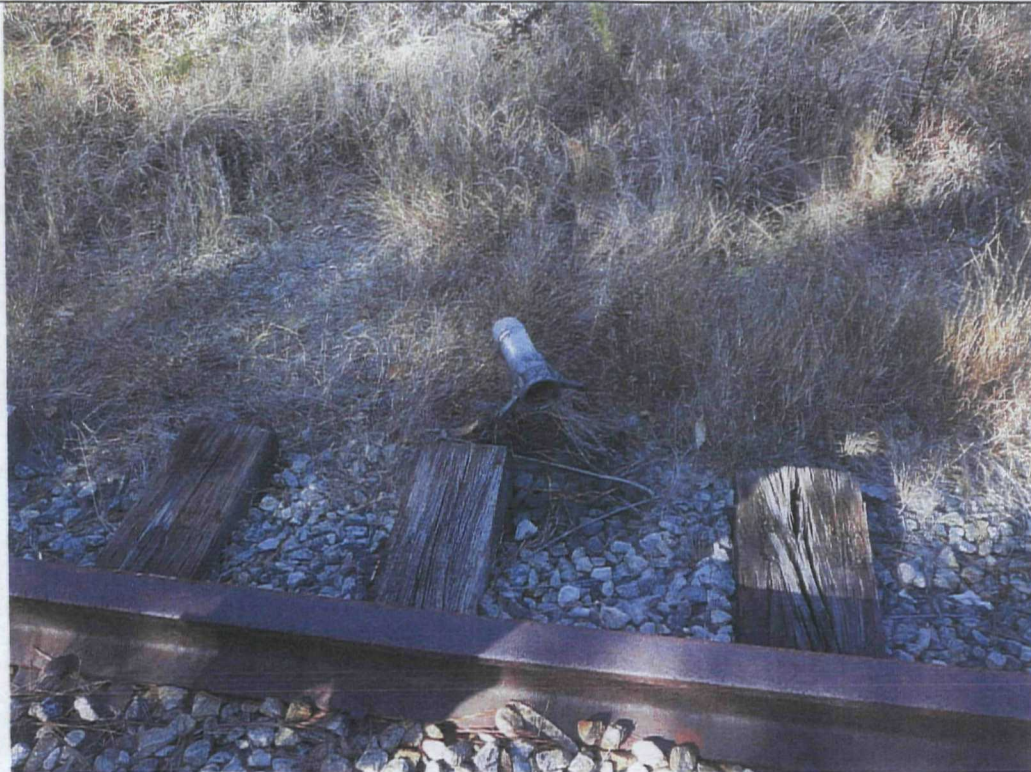
Photo	09 of 43	Date:	11/29/07	Site Name:	AZS Corporation		
Photographer:	Thomas J Brodell, QEP; HWMB			City:	Atlanta	County:	Fulton
Explanation:	Pipe with quick connect at railroad siding (western split) near former tank farm. Note soil staining under pipe. A second pipe was found alongside track approximately 75 feet to the North.					GPS:	Lat: 33.77665 Long: -84.42815

Open dumping was observed in several areas of the site. While most areas of the facility showed evidence of litter, several areas showed a small mound (less than one cubic yard) of domestic garbage, sometimes bagged, sometimes not. A tire dump was also observed near the southeastern corner of the property (see Photo # 23). Old industrial tanks, sumps and piping was also observed on-site (see Photo #s 09, 19 and 20). An old well casing was also observed on-site (see Photo #s 13 – 15).

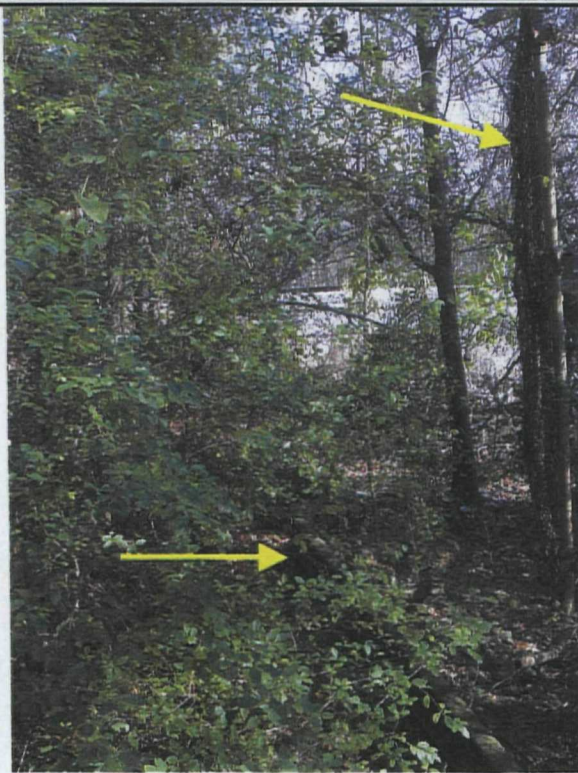
Photo	10 of 43	Date:	11/29/07	Site Name:	AZS Corporation		
Photographer:	Thomas J Brodell, QEP; HWMB			City:	Atlanta	County:	Fulton
Explanation:	Gate (top arrow) at eastern split of railroad siding (bottom arrow points to track rail). Gate is open and existing tree growth is in swing path of gate preventing gate from being fully closed.

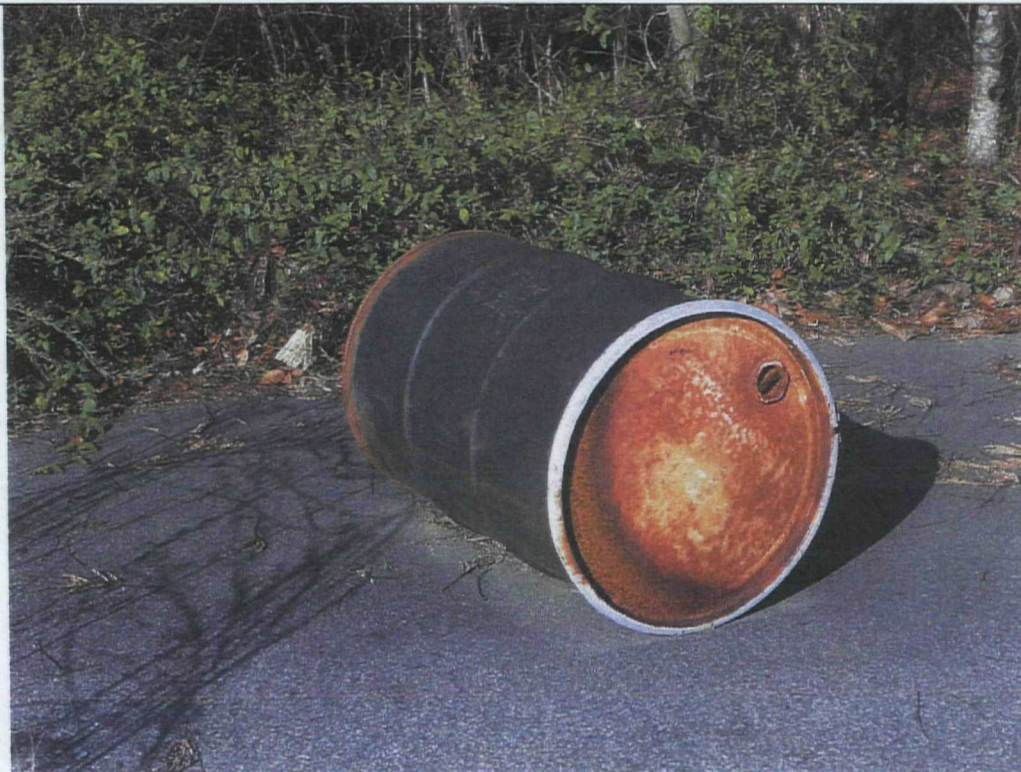
Photo	11 of 43	Date:	11/29/07	Site Name:	AZS Corporation		
Photographer:	Thomas J Brodell, QEP; HWMB			City:	Atlanta	County:	Fulton
Explanation:	55-gallon drum of solids on asphalt roadway between former Laboratory and former Polymer Warehouse. Faded writing on side of drum was undecipherable.

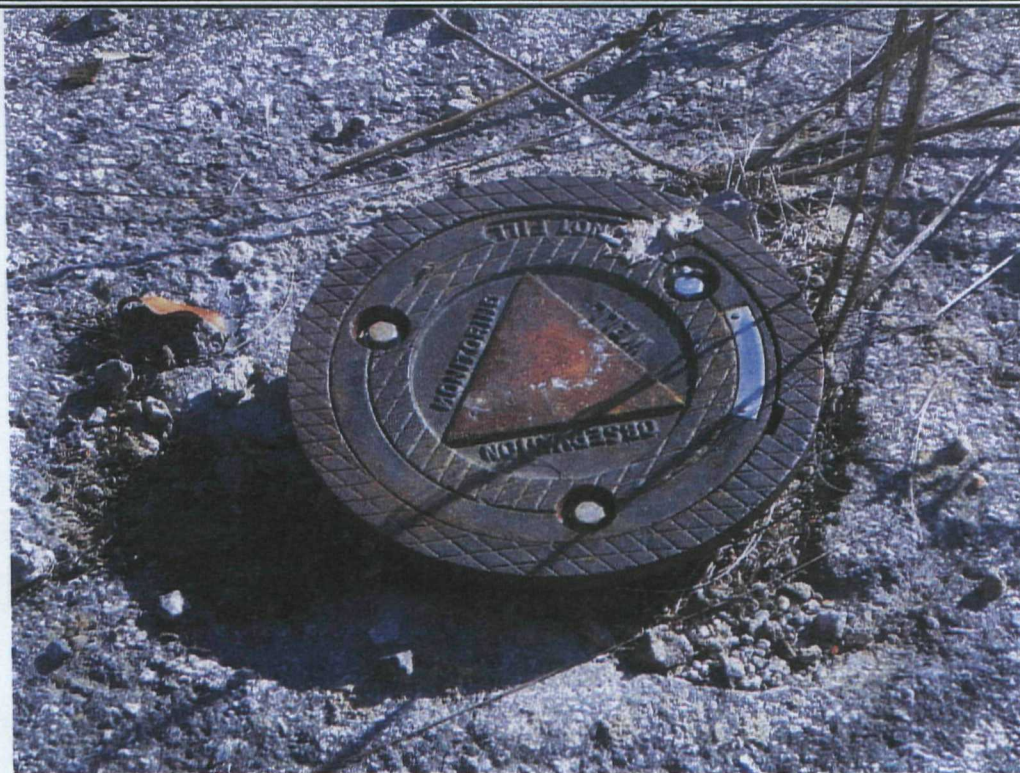
Photo	12 of 43	Date:	11/29/07	Site Name:	AZS Corporation		
Photographer:	Thomas J Brodell, QEP; HWMB			City:	Atlanta	County:	Fulton
Explanation:	Monitoring well found on asphalt roadway between former Laboratory and former Polymer Warehouse, near drum observed in Photo # 11. Well not observed during 2007 CEI.					GPS:	Lat: 33.77665 Long: -84.42815

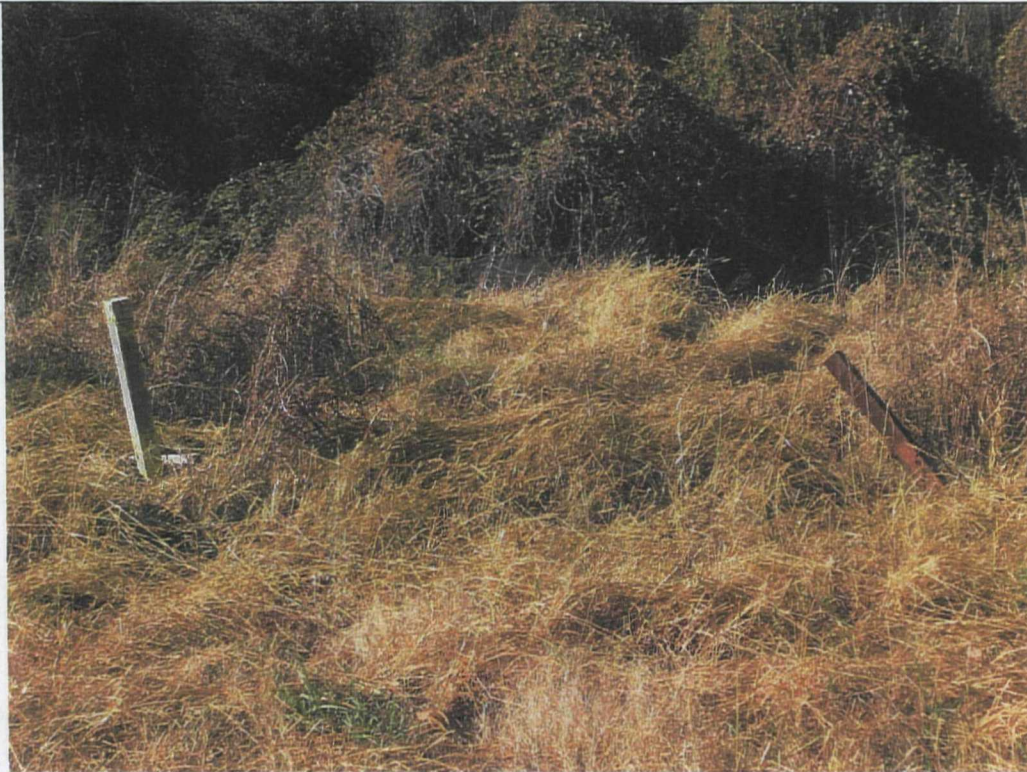
Photo	13 of 43	Date:	11/29/07	Site Name:	AZS Corporation		
Photographer:	Thomas J Brodell, QEP; HWMB			City:	Atlanta	County:	Fulton
Explanation:	Well on left is MW-2, Point Of Compliance Well for Polymer Pond. Cap does not appear to have been mowed since 2007 CEI. Rather, grass appears to have died off due to colder weather.

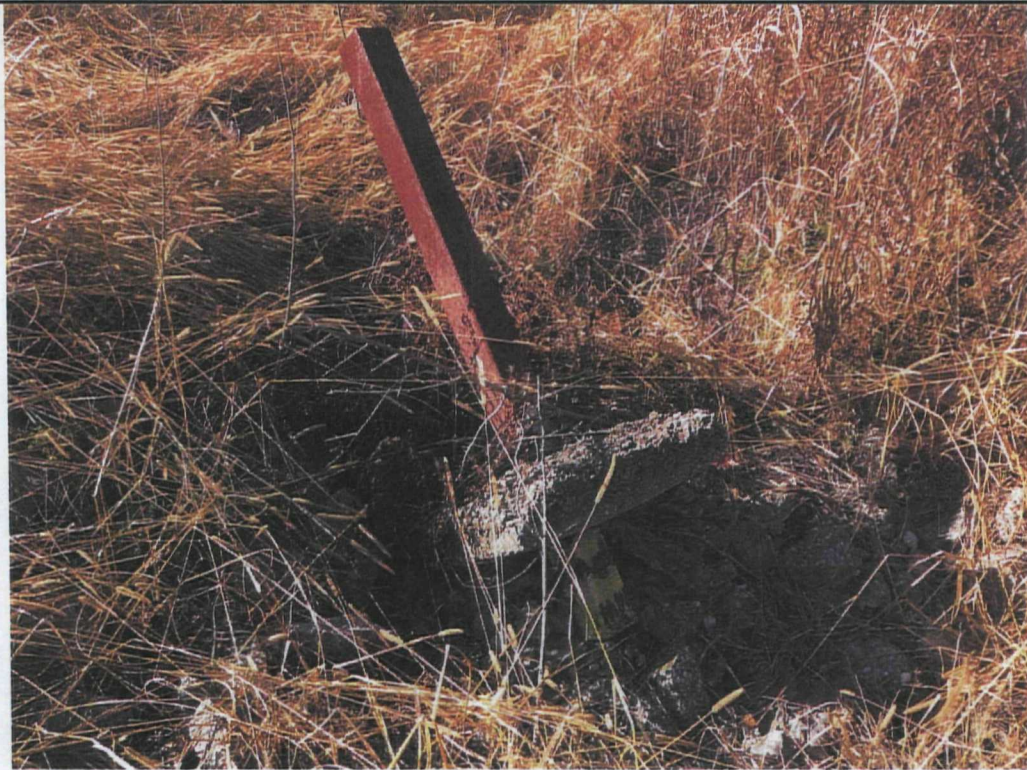
Photo	14 of 43	Date:	11/29/07	Site Name:	AZS Corporation		
Photographer:	Thomas J Brodell, QEP; HWMB			City:	Atlanta	County:	Fulton
Explanation:	Well housing seen on right of Photo # 13. Well housing not observed during 2007 CEI, possibly due to overgrowth in area.

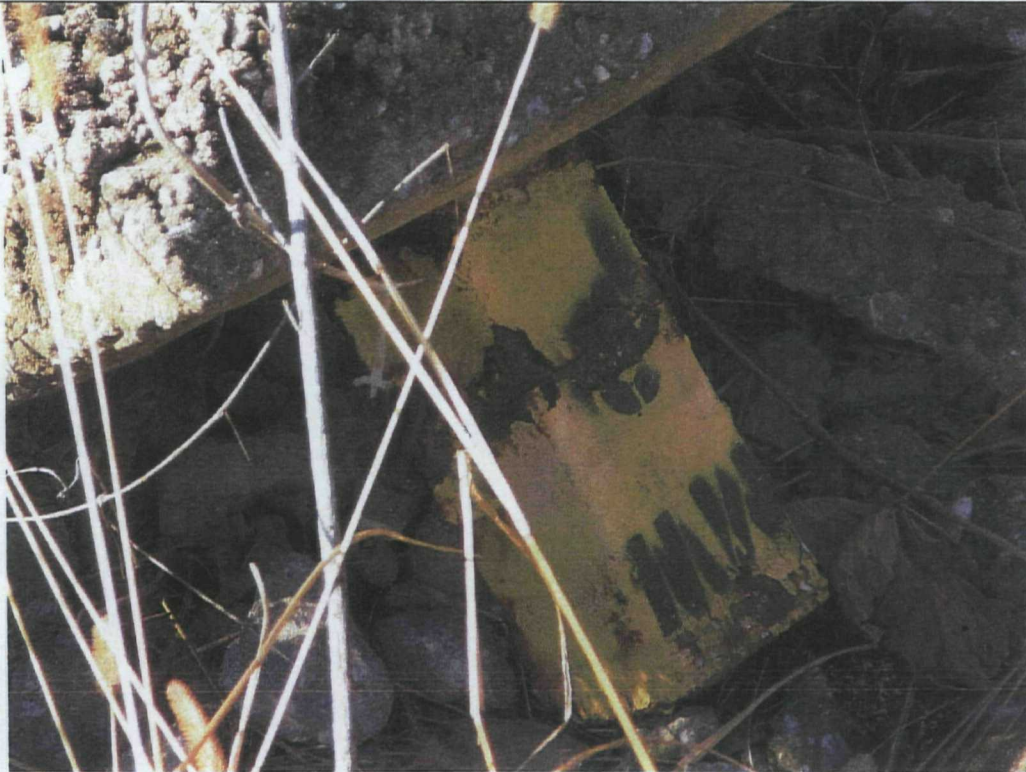
Photo	15 of 43	Date:	11/29/07	Site Name:	AZS Corporation		
Photographer:	Thomas J Brodell, QEP; HWMB			City:	Atlanta	County:	Fulton
Explanation:	Close up of well housing from Photo #s 13 and 14. Appears to be a former housing for MW-2.

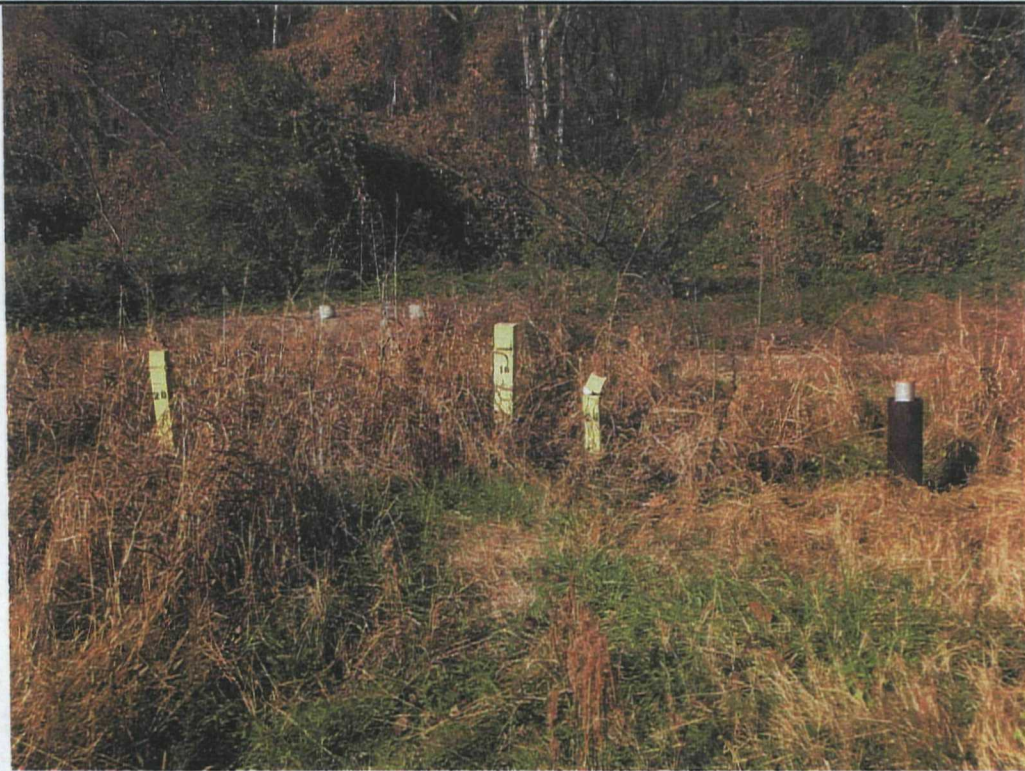
Photo	16 of 43	Date:	11/29/07	Site Name:	AZS Corporation		
Photographer:	Thomas J Brodell, QEP; HWMB			City:	Atlanta	County:	Fulton
Explanation:	From left to right: MW-20, MW-18, MW-24, RW-1. No wells in photo are locked, and protective casing cap for MW-24 will not close.

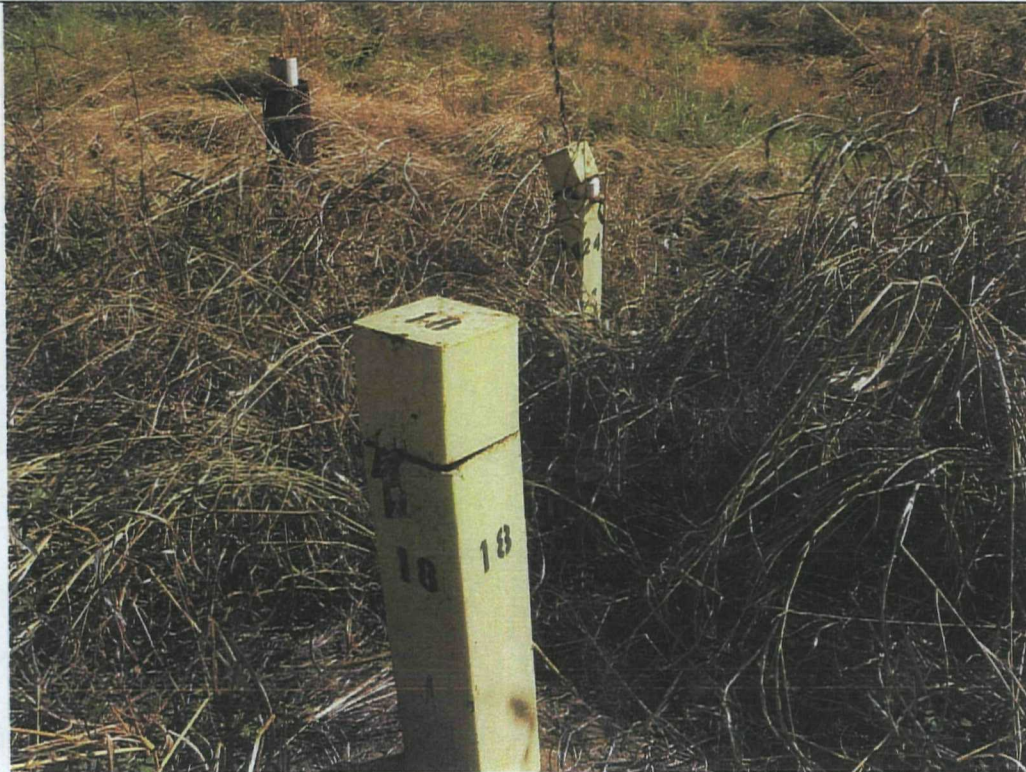
Photo	17 of 43	Date:	11/29/07	Site Name:	AZS Corporation		
Photographer:	Thomas J Brodell, QEP; HWMB			City:	Atlanta	County:	Fulton
Explanation:	Second view of MW-18, MW-24 and RW-1, showing no locks present.

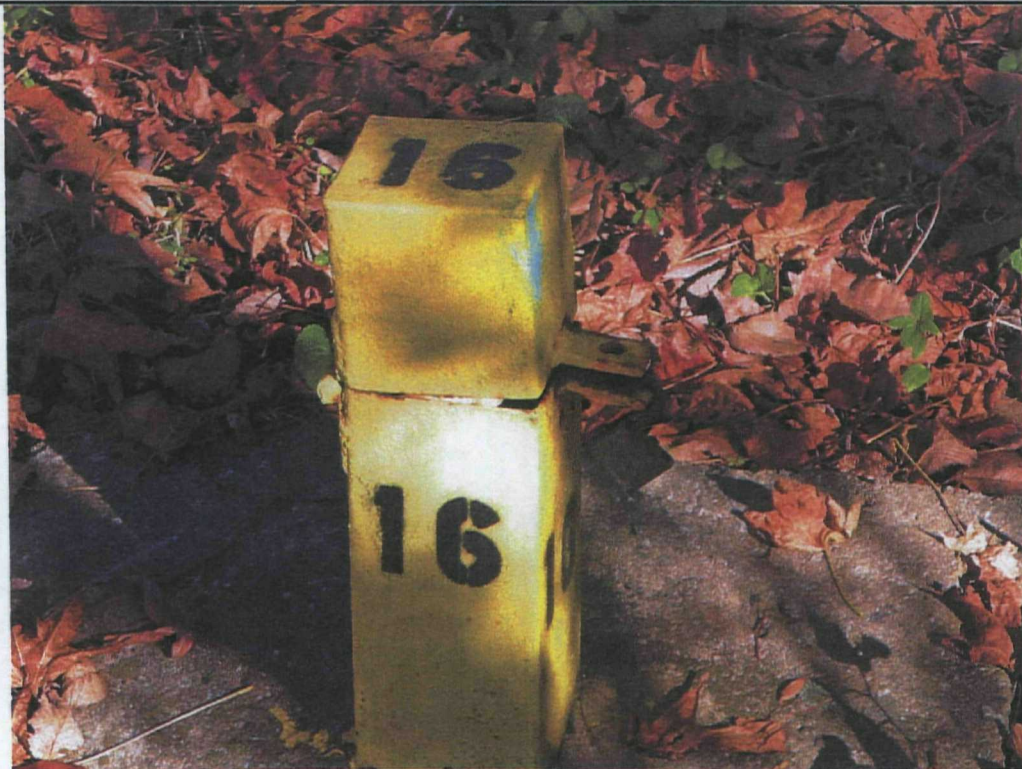
Photo	18 of 43	Date:	11/29/07	Site Name:	AZS Corporation		
Photographer:	Thomas J Brodell, QEP; HWMB			City:	Atlanta	County:	Fulton
Explanation:	MW-16 located cross-gradient of the Polymer Pond. Lock is present, but not locked.

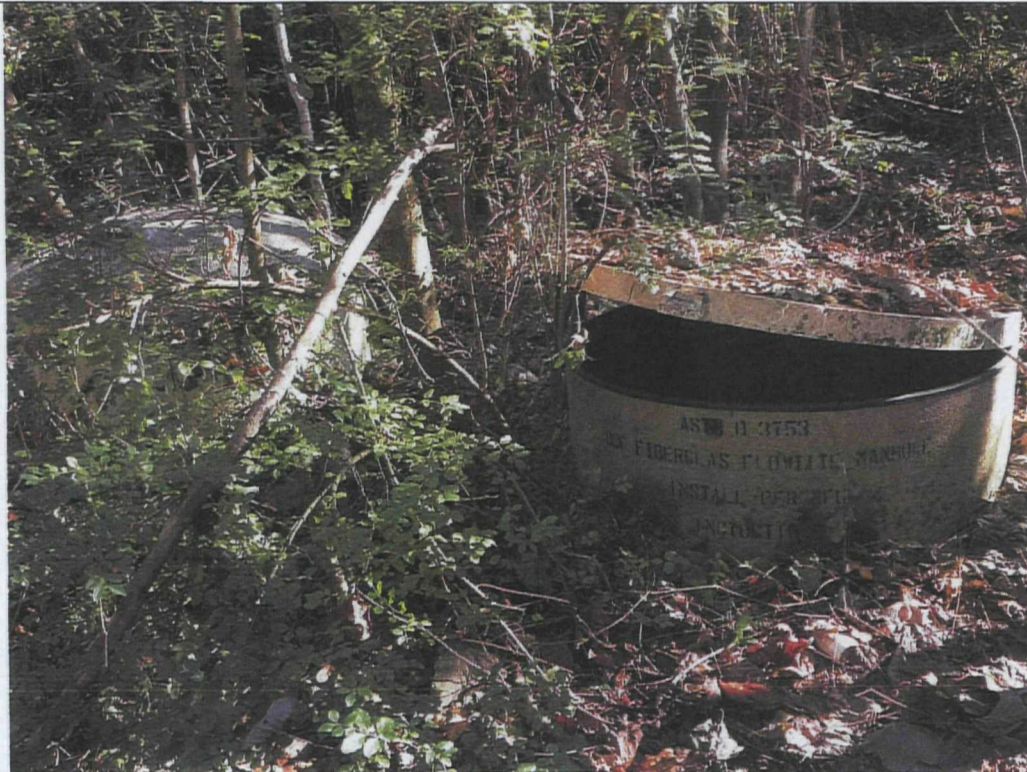
Photo	19 of 43	Date:	11/29/07	Site Name:	AZS Corporation		
Photographer:	Thomas J Brodell, QEP; HWMB			City:	Atlanta	County:	Fulton
Explanation:	Two partially buried tanks located adjacent to and northwest of the former R&D Laboratory and Office. Tanks and vault pictured in Photo # 20 appear to be part of the wastewater pretreatment system.

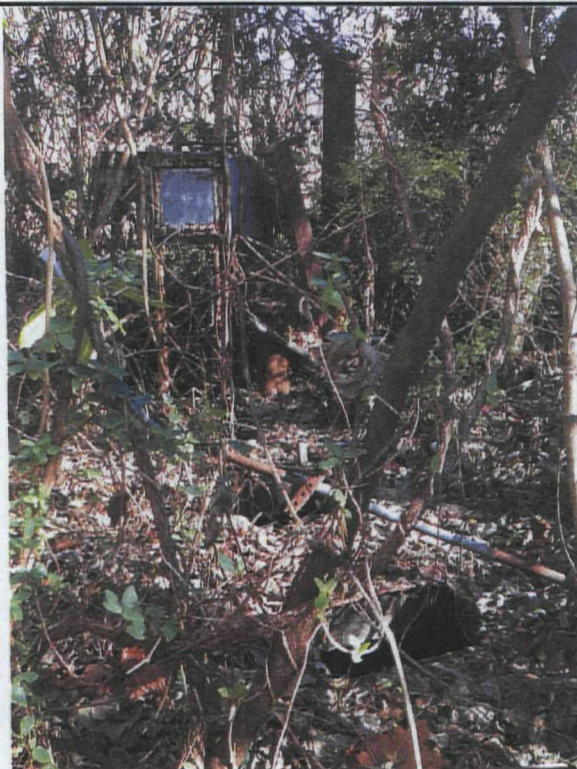
Photo	20 of 43	Date:	11/29/07	Site Name:	AZS Corporation		
Photographer:	Thomas J Brodell, QEP; HWMB			City:	Atlanta	County:	Fulton
Explanation:	Vault located between tanks pictured in Photo # 19 and the former R&D Laboratory and Office. Vault and tanks pictured in Photo # 19 appear to be part of the wastewater pretreatment system.

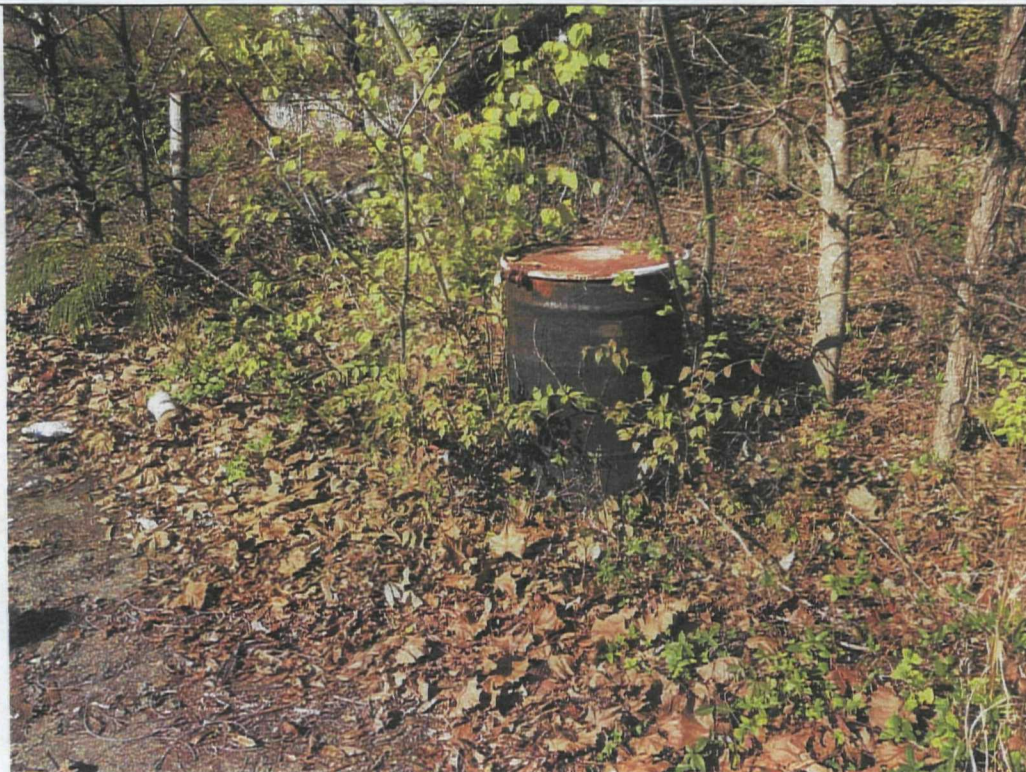
Photo	21 of 43	Date:	11/29/07	Site Name:	AZS Corporation		
Photographer:	Thomas J Brodell, QEP; HWMB			City:	Atlanta	County:	Fulton
Explanation:	Drum with solids not previously observed during 2007 CEI, possibly due to overgrowth. Drum is approximately 20 yards from drum pictured in Photo # 22.					GPS:	Lat: 33.77495 Long: -84.42712

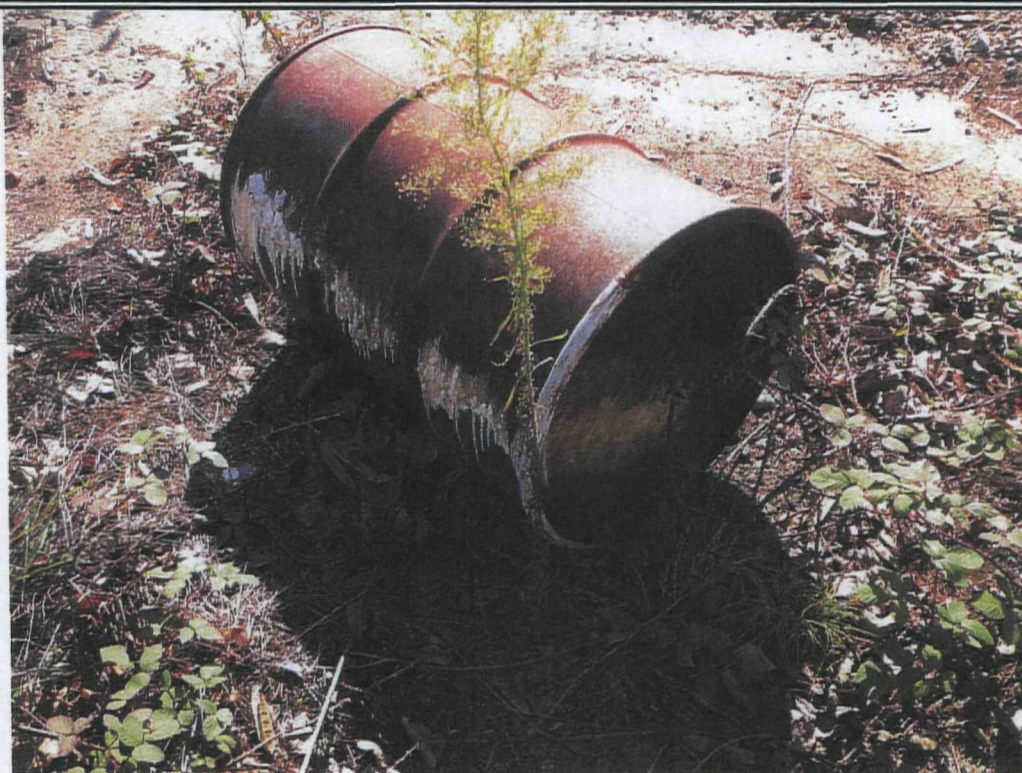
Photo	22 of 43	Date:	11/29/07	Site Name:	AZS Corporation		
Photographer:	Thomas J Brodell, QEP; HWMB			City:	Atlanta	County:	Fulton
Explanation:	55-gallon drum of solids near the former finishing plant diesel fuel tank. No labeling visible and corrosion evident on side of drum with white salt formation. Drum observed during 2007 CEI.					GPS:	Lat: 33.77478 Long: -84.42780

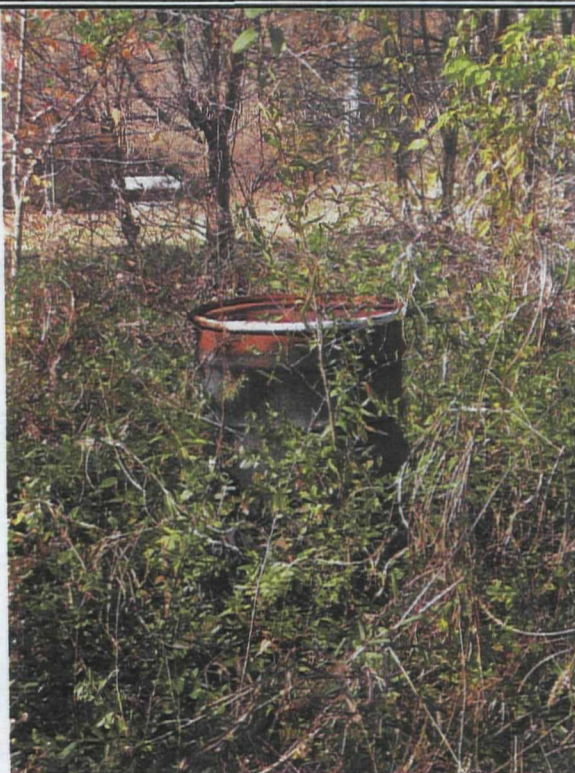
Photo	24 of 43	Date:	11/29/07	Site Name:	AZS Corporation		
Photographer:	Thomas J Brodell, QEP; HWMB			City:	Atlanta	County:	Fulton
Explanation:	Drum with solids not previously observed during 2007 CEI, possibly due to overgrowth. Series pond and ground water treatment system visible in background					GPS:	Lat: 33.77478 Long: -84.42780

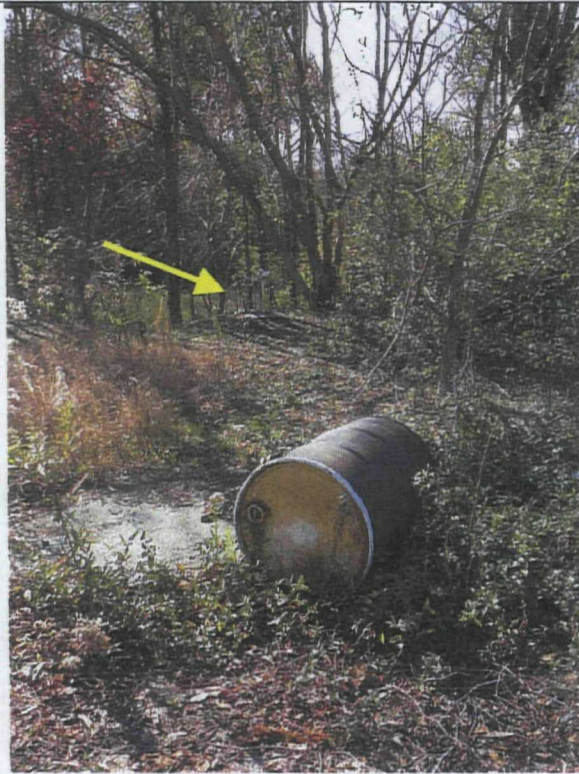
Photo	25 of 43	Date:	11/29/07	Site Name:	AZS Corporation		
Photographer:	Thomas J Brodell, QEP; HWMB			City:	Atlanta	County:	Fulton
Explanation:	55-gallon drum of solids near MW-13 (see arrow pointing at well). Drum observed during 2007 CEI.

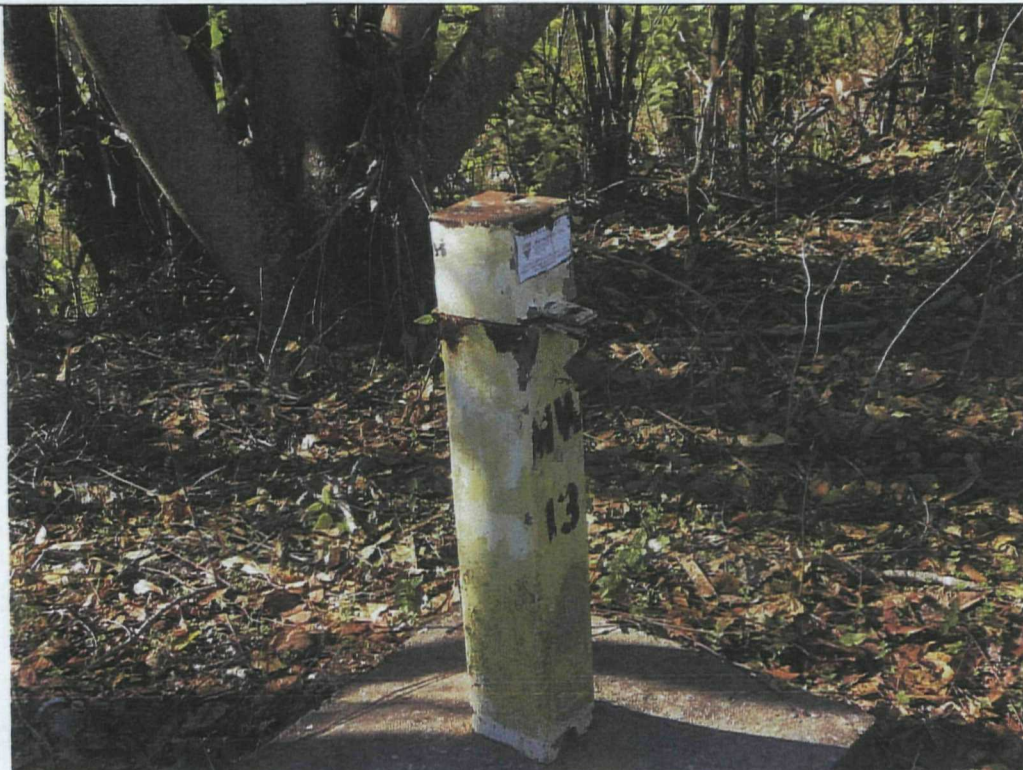
Photo	27 of 43	Date:	11/29/07	Site Name:	AZS Corporation		
Photographer:	Thomas J Brodell, QEP; HWMB			City:	Atlanta	County:	Fulton
Explanation:	Close up of MW-13 with open, rusted lock hanging on well casing.

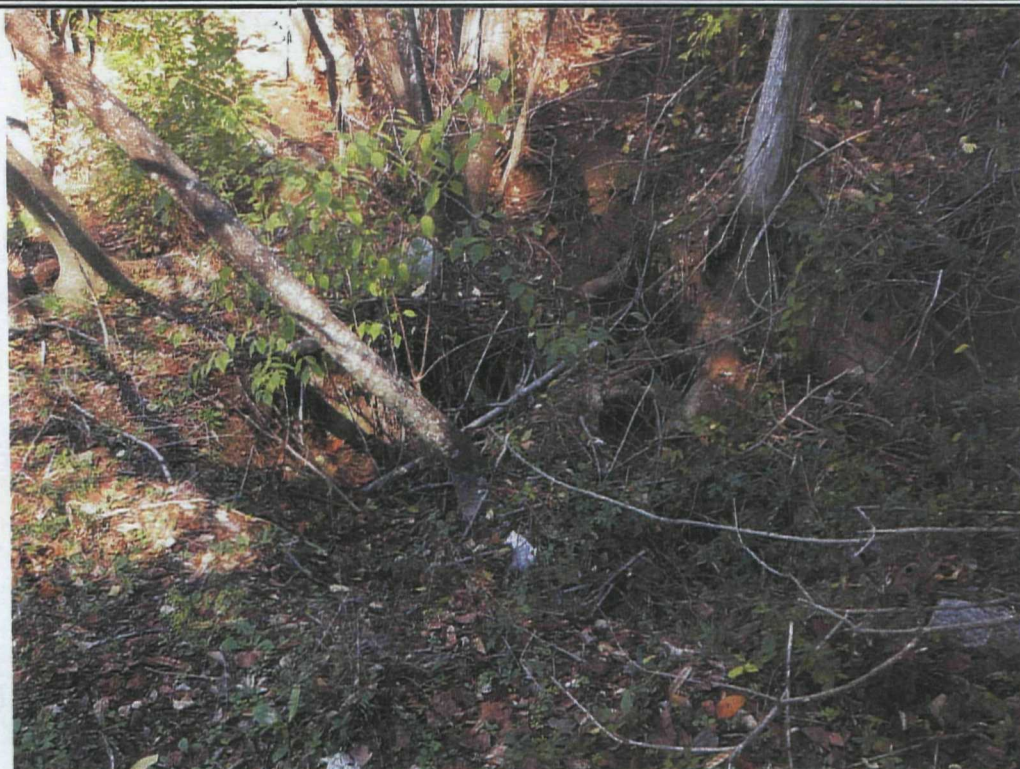
Photo	28 of 43	Date:	11/29/07	Site Name:	AZS Corporation		
Photographer:	Thomas J Brodell, QEP; HWMB			City:	Atlanta	County:	Fulton
Explanation:	Sinkhole observed on or at edge of Series Pond cap. This photo is first in a panoramic series of three showing location. Sinkhole not observed during 2007CEI, possibly due to overgrowth.					GPS:	Lat: 33.77494 Long: -84.42795

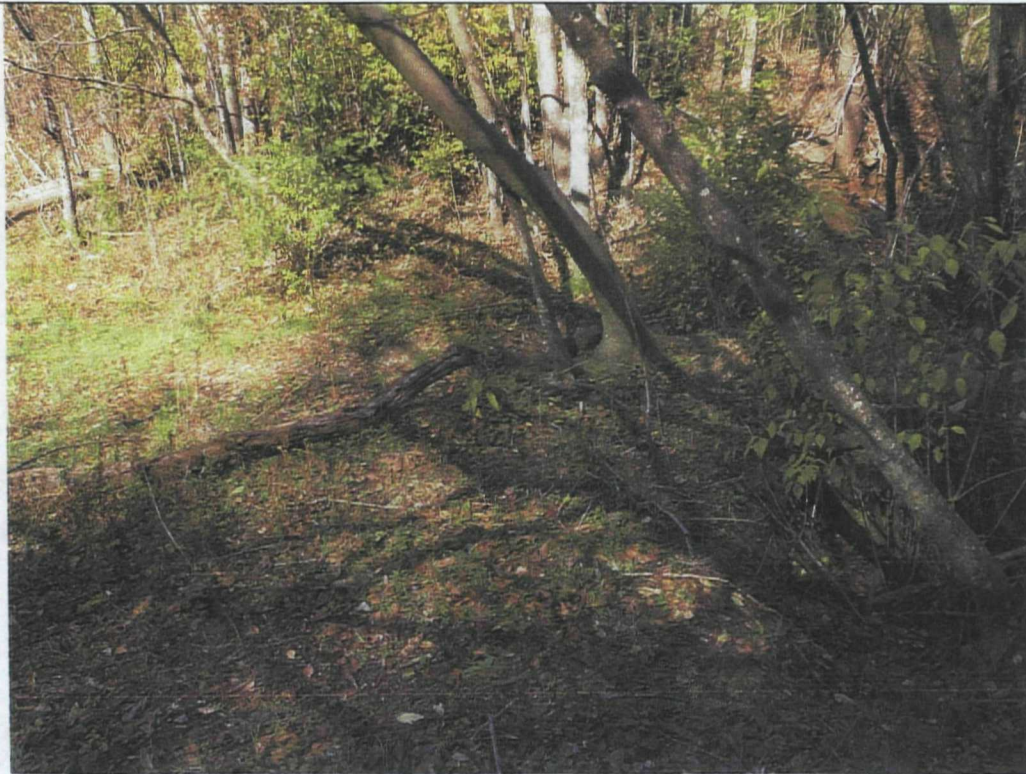
Photo	29 of 43	Date:	11/29/07	Site Name:	AZS Corporation		
Photographer:	Thomas J Brodell, QEP; HWMB			City:	Atlanta	County:	Fulton
Explanation:	Second photo in a panoramic series of three, turning counter-clockwise from Photo # 30. Sinkhole is visible in the lower right portion of photo.

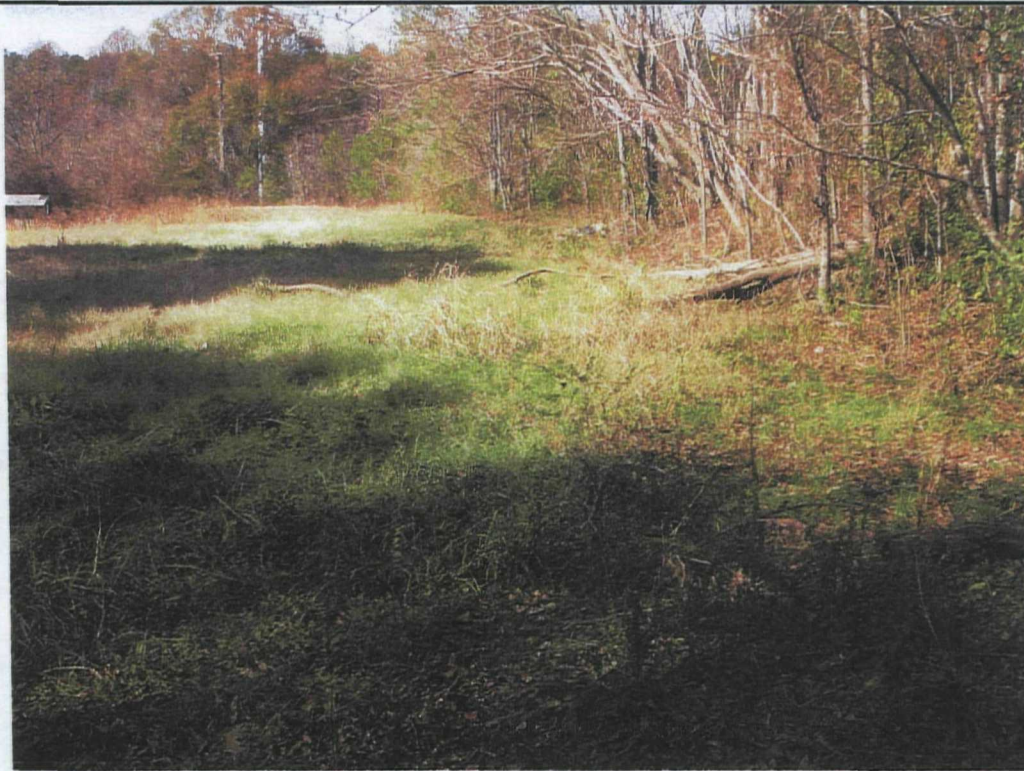
Photo	30 of 43	Date:	11/29/07	Site Name:	AZS Corporation		
Photographer:	Thomas J Brodell, QEP; HWMB			City:	Atlanta	County:	Fulton
Explanation:	Third photo in a panoramic series of three looking out over the Series Pond, and turning counter-clockwise from Photo # 29. Wastewater treatment shed visible on left side of photo.

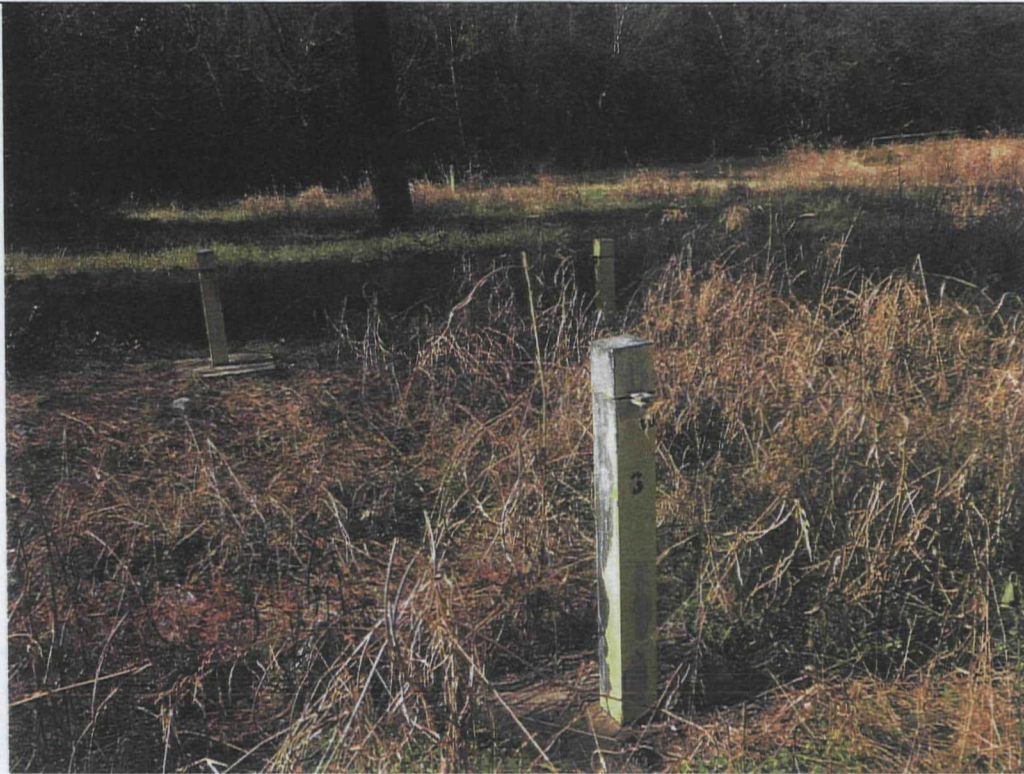
Photo	31 of 43	Date:	11/29/07	Site Name:	AZS Corporation		
Photographer:	Thomas J Brodell, QEP; HWMB			City:	Atlanta	County:	Fulton
Explanation:	MW-6 (foreground), MW-31 (back, left) and MW-32. None of the wells were locked, however, all three were observed with rusted, open locks hanging on well casings.

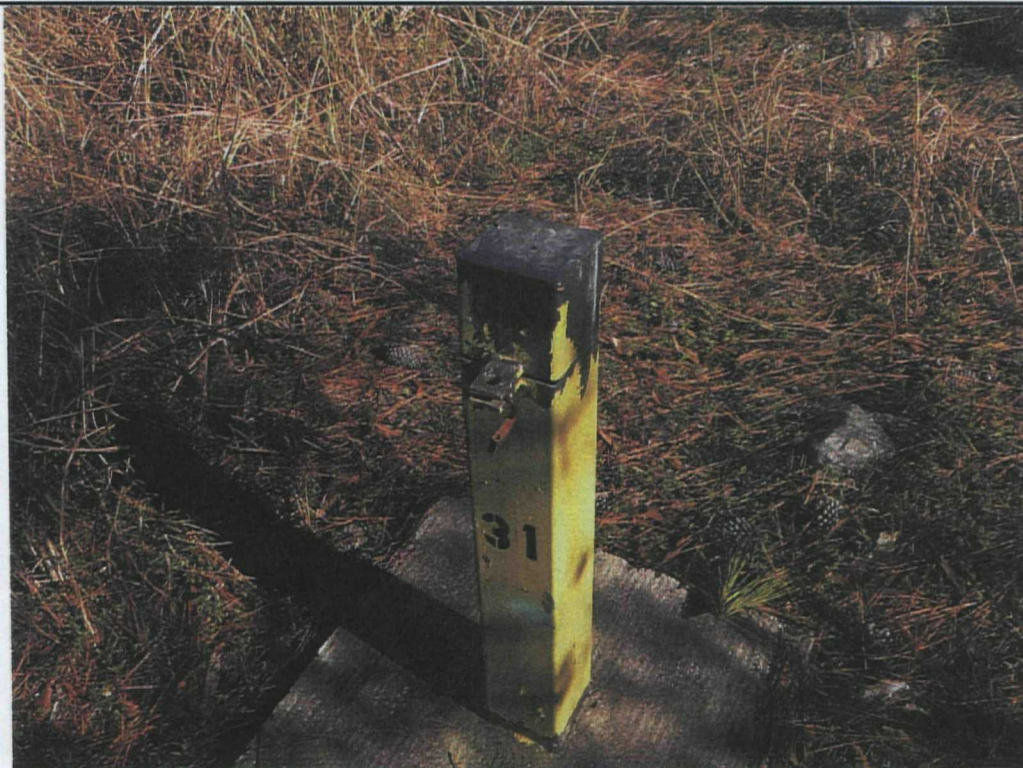
Photo	32 of 43	Date:	11/29/07	Site Name:	AZS Corporation		
Photographer:	Thomas J Brodell, QEP; HWMB			City:	Atlanta	County:	Fulton
Explanation:	Rusted, open lock hanging on well casing for MW-31.
